**CANADIAN FORCES
FLIGHT SAFETY INVESTIGATION REPORT**

FINAL REPORT

FILE NUMBER: 1010-C-GMFB (DFS 2-6)
DATE OF REPORT: 28 January 2005

AIRCRAFT TYPE: Katana
DATE/TIME: 211100Z July 2004
LOCATION: Moncton Airport, New Brunswick
CATEGORY: "C" Category Accident

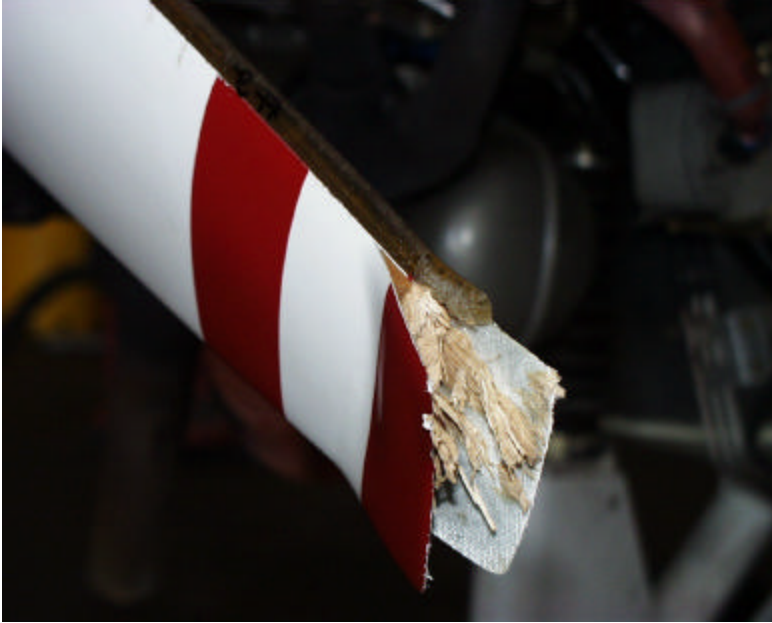
The aircraft received "C" category damage (Annex A). The aircraft propeller struck the ground resulting in damage to the outboard two-inch portion of both propellers' tips. The outer cover of the wood cored propeller split and the wooden core was abraded by contact with the ground. The nose gear pivoting axel and strut were bent and the nose shock was deformed. No further damage was discovered following inspection of the engine during the engine teardown according to the Director of Maintenance at the Moncton Flying Club. As a result

Photo 1: Damage to propeller

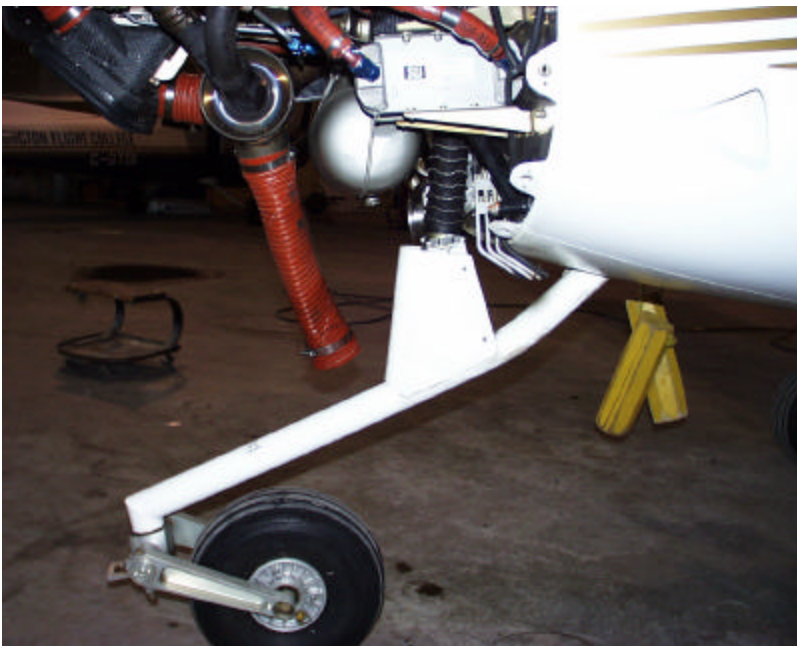
Photo 2: Damage to nose gear shock (overview)

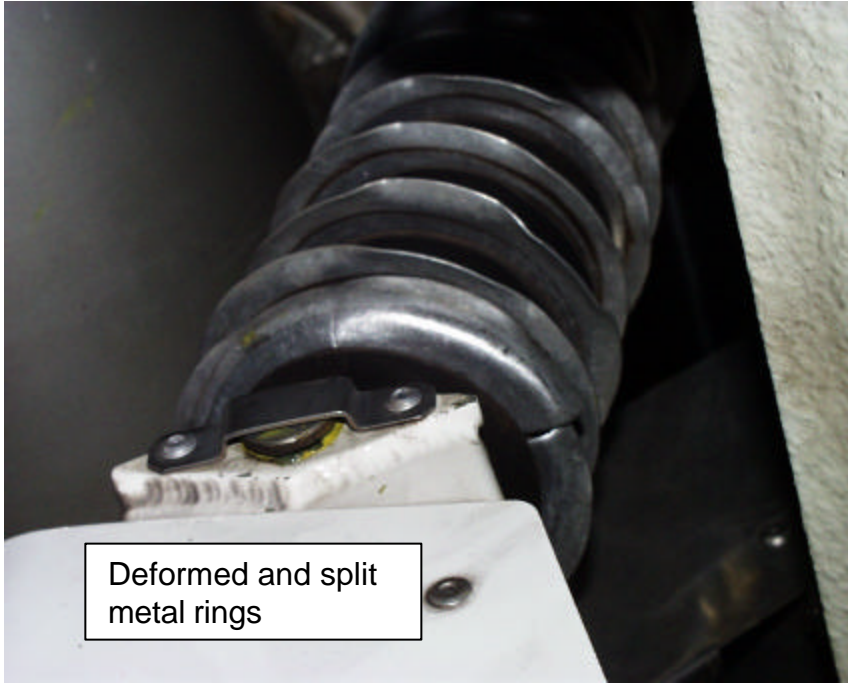
Photo 3: Close-up view of damage to nose gear shock
